SERVICE INFORMATION

No. : SI-V48117-G

MODEL : CLD-A100 g S/M NO :: ARP2757 PAGE : 11,13,14

CLD-A100 LaserActive

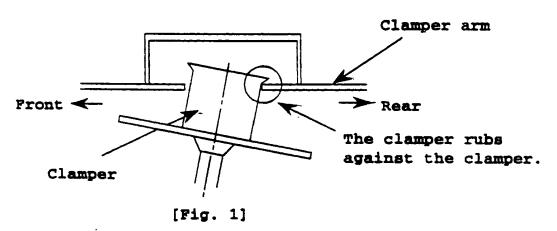
<CAUSE>

When an LD disc is clamped, the motor center axis is slanted due to:

- The height of the mech mounting portions on the Chassis is lower by 0.5mm.
- The mounting position of the mechanism is deviated toward the rear side.

Therefore, the clamper rubs against the clamper arm at the rear side.

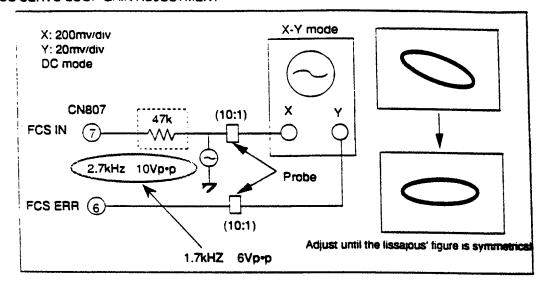
FCS SERVO LOOP GAIN ADJUSTMENT

MODEL [S/M NO.]	PAGE	INCORRECT	CORRECT
CLD-A100 (ARP2757)	80
