Service Bulletin

Product	Laser Disk Player
Number	B10-92-6
Date	June 1992

Panasonic LX-1000U, LX-200U

Subject: Video Cross-Talk Problem.

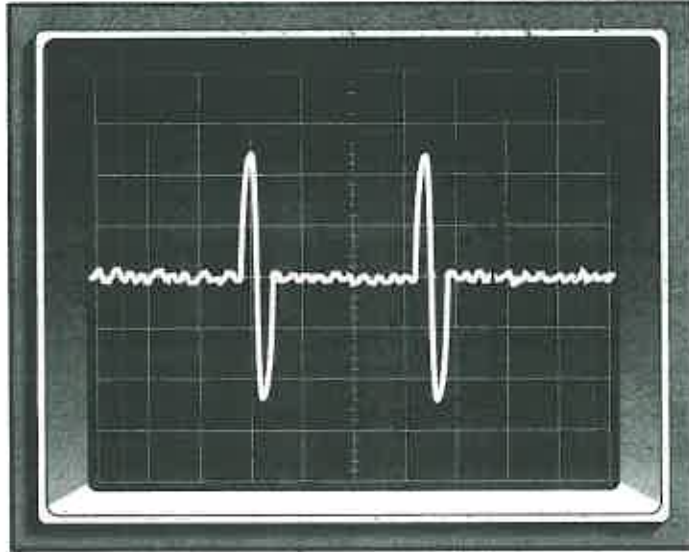
- (2-1) Hook up scope probe to TP22003.

- (2-2) Play back FRAME #1510 of CAV side of Test Disc VFK0652 (MTD-01 version) in STILL mode.

(2-3) Adjust VR22301 to maximize spike of Tracking Error signal(T.E.).

(2-5) Adjust VR22302 to maximize spike of T.E. signal.
