SERVICE INFORMATION

No. : SI-V44029-G
Date. : Jan. 5, 1990

PIONEER															
MODEL NO.		*	SER. NO.		MODEL NO.		*	SER. NO.		MODEL NO.		*	SER. NO.		
CLD-3070/KU/CA		A	JL3919001-												
CLD-3070/SD/G		A	JL2914501-												
#	DETAIL OF CHANGE(S)							REASON FOR CHANGE(S)							
1	Deletion of a PCB hinge and addition of rubber cushions to the shield case for VSOP ASS'Y							X	To prevent VSOP ASS'Y from cracking

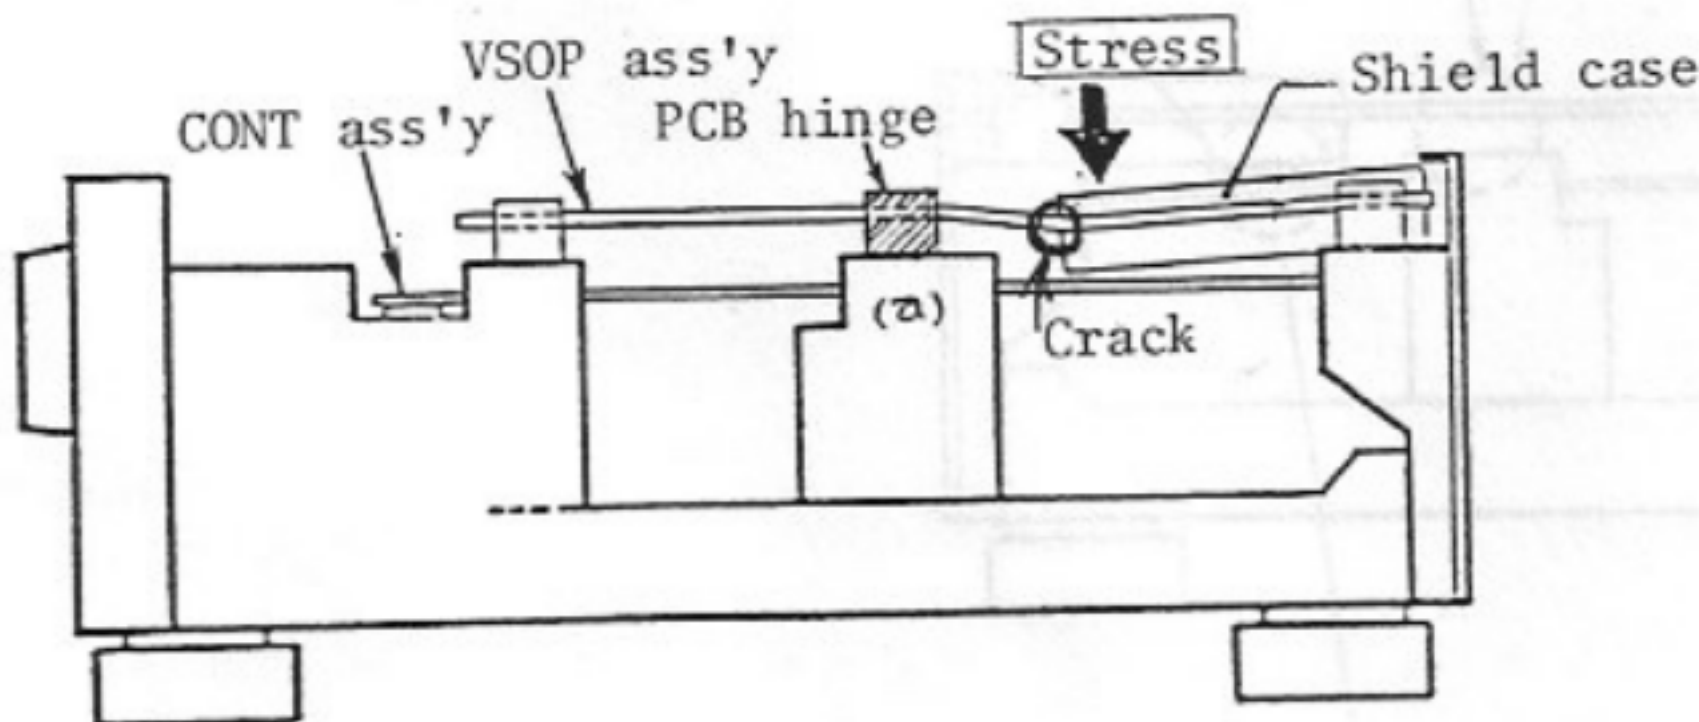
VSOP Ass'y cracks at a certain point.

While the unit is being transported or handled, excessive stress is applied to VSOP ass'y at the position around a PCB hinge as indicated with (a).
