SERVICE INFORMATION

No. : SI-V47075-G

Date: Jan. 18, 1993

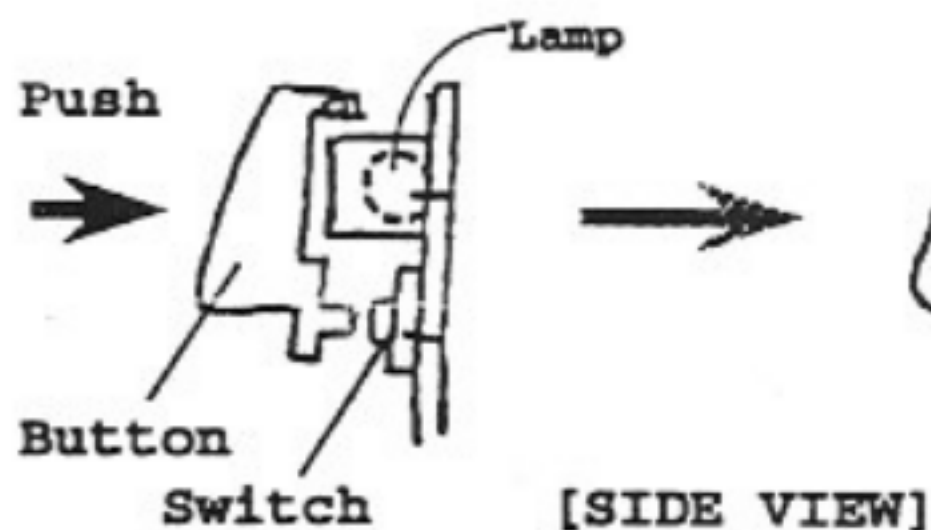
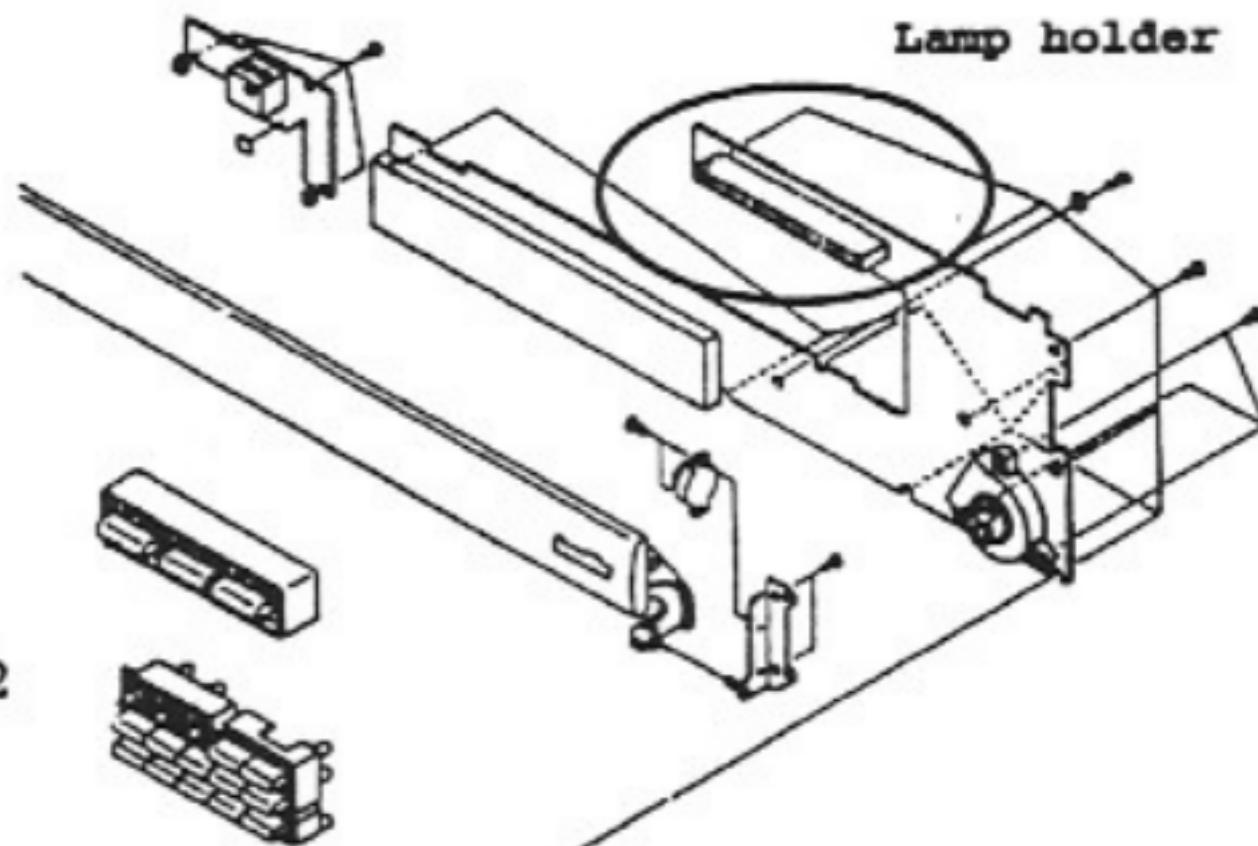
<problem> Disc side won't be changed with the DISC SIDE buttons pushed.

<CAUSE> The lamp holder for Disc side indication gets deformed by heat when the ambient temperature is high. So, the Disc side button can't push the switch properly.

Deformed by heat.

Changed the material for the lamp holder.

When you encounter the above problem, please replace the lamp holder with the new part (VNL1532).
